NWC TP 5003
COPY 93

MIDWAY ISLANDS CLOUD SEEDING PROGRAM, JULY 1969

by
S. D. Elliott, Jr.

NAVAL WEAPONS CENTER
CHINA LAKE, CALIFORNIA * DECEMBER 1970

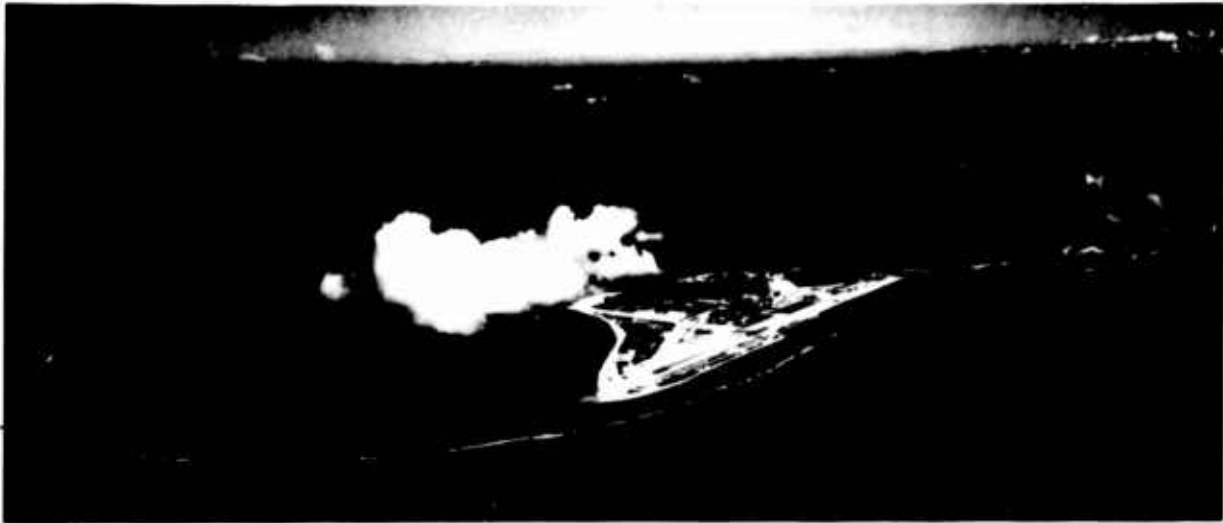
FIG. 2. Midway Islands, Oblique View From Southwest. Sand Island in center foreground, Eastern Island to right.

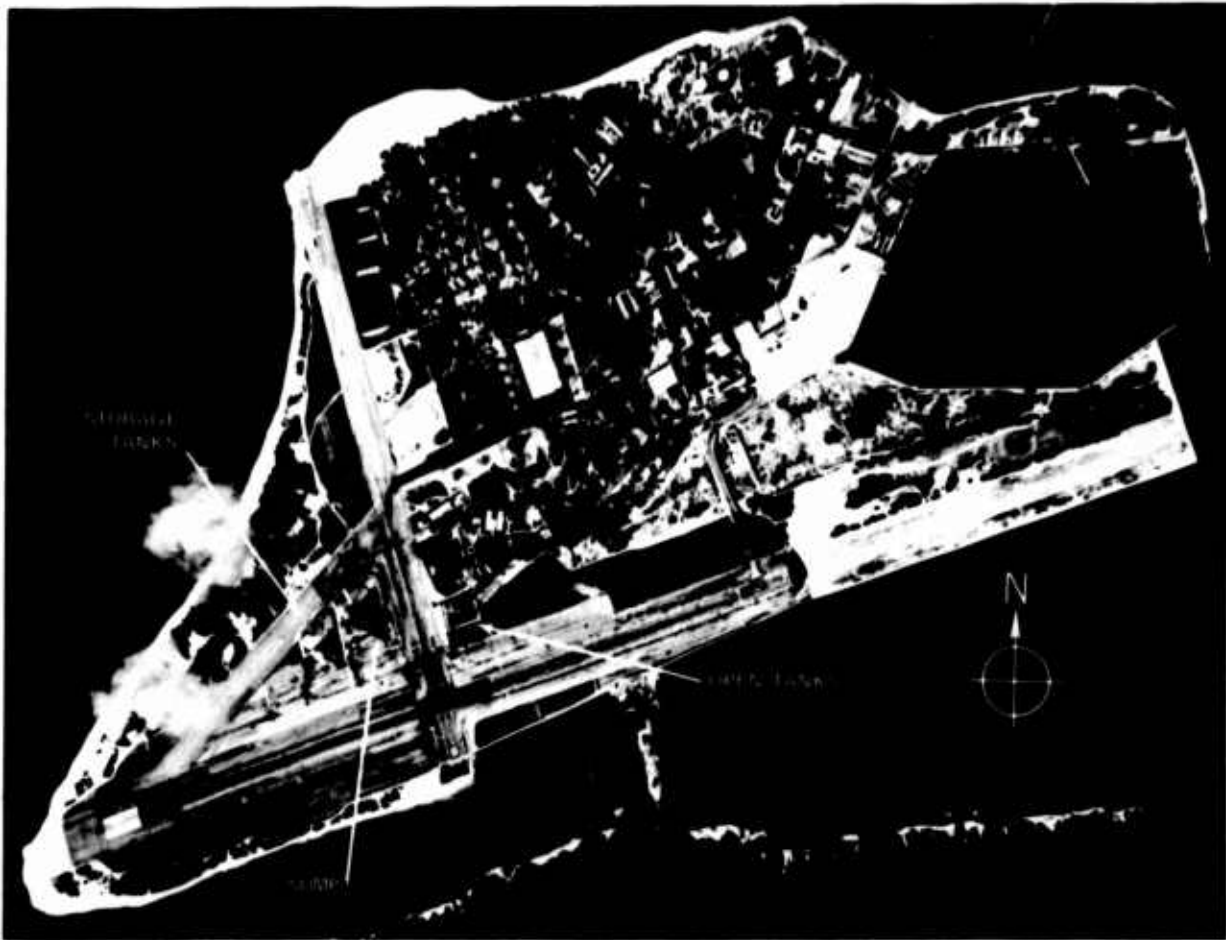
FIG. 3. Sand Island. Fresh and brackish water collection and storage areas lower left; Runway 06 overrun landfill right center.

The atoll consists of two inhabited islands, Sand and Eastern, totaling 3 square miles in area, and several smaller islets, enclosed within a reef approximately 5 miles in diameter. A general view of the islands as seen from the southwest is shown in Fig. 2, with Sand Island in the foreground. This island, 2 miles long by 1 mile wide, with a maximum elevation of a few tens of feet, houses all but approximately 50 of the 2,300 personnel—military and civilian—residing in the islands, and is shown in more detail in Fig. 3.

The runways, taxiways, and parking aprons are graded, surfaced, and embanked to provide a catchment area for rainwater. The fresh water thus collected is channeled into a sump visible as a small dark triangle between the two runways and the diagonal taxiway to the lower left in Fig. 3. From this sump the water may be pumped into the three 4-million-gallon storage tanks lying just to the west. The water from these tanks is then purified, chlorinated, and otherwise treated, batchwise, in one of the four 1.1-million-gallon square open tanks, lying to the east of the sump, just across Runway 33. The purified water is then stored in two half-million-gallon underground holding tanks in the community area and pumped as needed into a tower tank in the center of the island for delivery by gravity to the fresh water system. The ultimate capacity of this system is thus somewhat over 17 million gallons if all four treatment tanks are used for storage. This is generally impractical, however, and a figure of 13 to 15 million gallons is more representative.

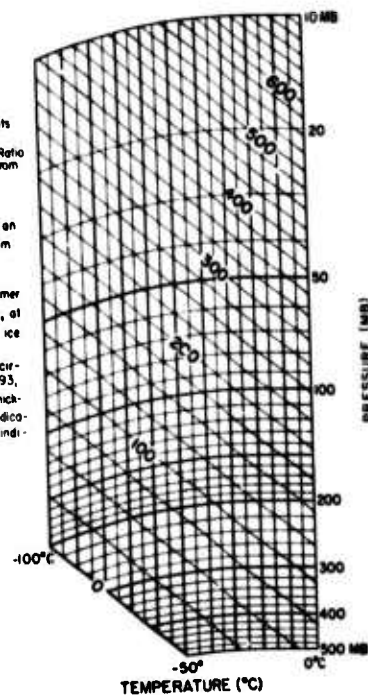
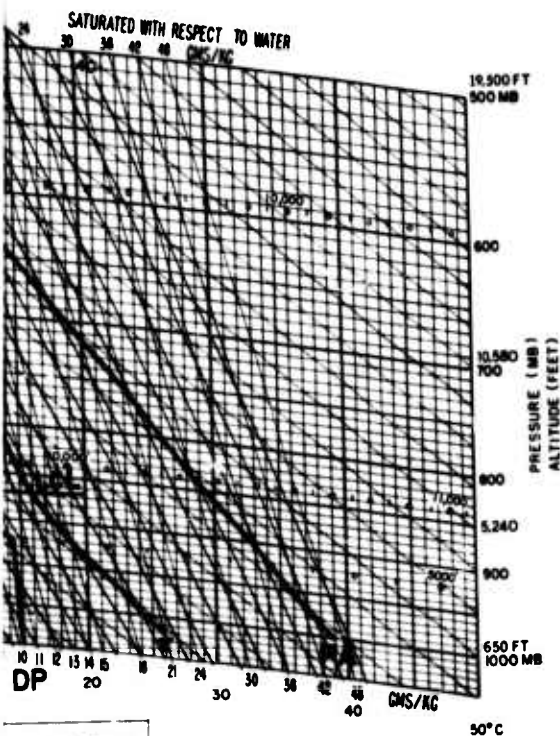
- ① Isobars - p in mb
- ② Dry Adiabats θ in $^{\circ}\text{C}$
- ③ Saturation Adiabats θ_{sat} in $^{\circ}\text{C}$
- ④ Saturation Mixing Ratio w_s in grams/kg
- ⑤ Isotherms - t in $^{\circ}\text{C}$

USE THE ARRAY FOUND AT	
923 MB	
838 MB	
593 MB	
300 MB	
245 MB

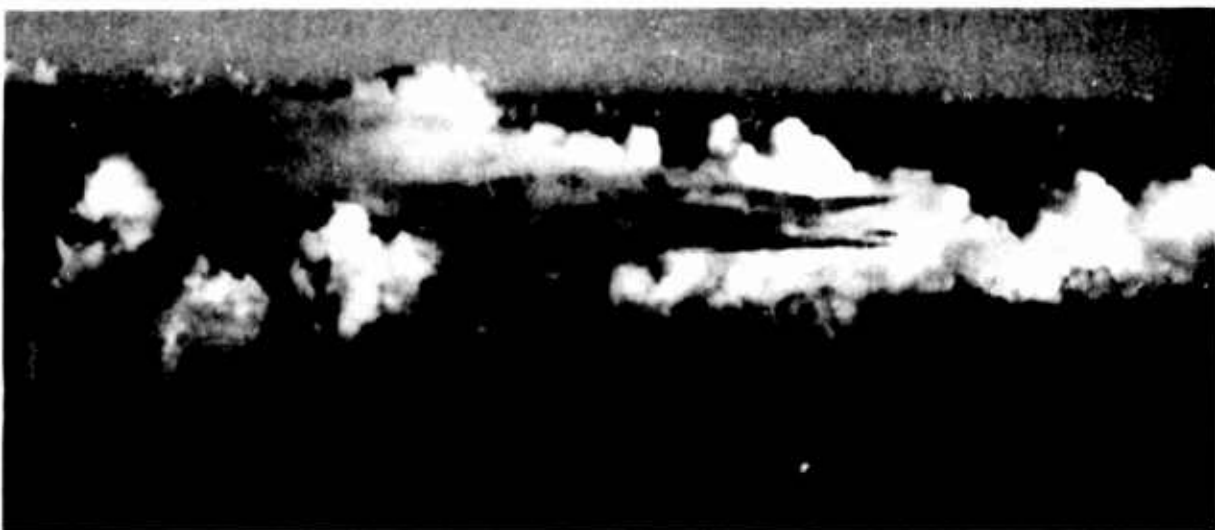
FIG. 5. Typical Precipitating Tradewind Cumulus Group Southwest of Midway, 12 July. Apex of cloud (left of center) is at 11,500 feet; a small shower is visible directly below.

with only the most vigorous growing above the tops of the moist layer. These latter almost invariably evaporated immediately upon entering the dry layer, the resultant cooling effect terminating upward convection while the residual larger drops fell back to form brief showers or spread into altostratus patches at the top of the moist layer. These showers were generally small, less than a mile in diameter, and lasted from 20 minutes to perhaps an hour. Such shower activity was encountered on virtually every day of observation, and over a dozen passed wholly or partially over the island. The maximum rainfall produced by one of these showers amounted to 0.22 inch and was insufficient to activate the water collection system; the majority of such showers yielded only trace precipitation. A typical example is illustrated in Fig. 5.

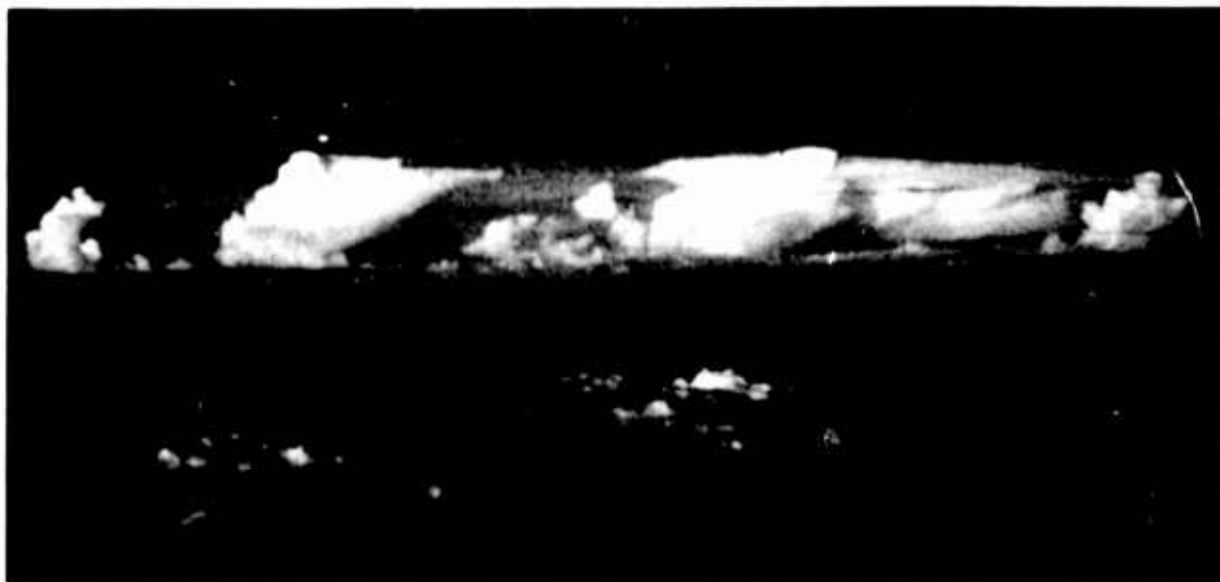
FIG. 6. Cumulonimbus Line Lying East-Southeast/West-Northwest 175 Miles South of Midway, 11 July. Tops of main cells, approximately 35,000 feet. Developing clouds to left of mass in center were later seeded successfully.

Convective activity in these low clouds was very weak; updrafts encountered on penetrations did not exceed 300 to 500 ft/min. In the few tall clouds extending above the freezing level, precipitation appeared to be initiated by homogenous nucleation, through the cooling produced by rapid evaporation. In the few seedable clouds (i.e., those showing relatively rapid growth, little or no evaporation, and high supercooled liquid water content), the rapid and dramatic response achieved by seeding suggests a relative scarcity of natural heterogeneous freezing nuclei. These cloud groups, which on at least two occasions achieved the status of lines of cumulonimbus activity, formed along a direction paralleling the archipelago (east-southeast/west-northwest) but lying 50 to 200 miles to the south of Midway (Fig. 6).
